# Inspection Report

## Wilden Building Services

**1121 Murray Valley Highway, Wharparilla, Victoria, 3564**

Report/Agreement # 31072608375953  
Inspection Date: 31 Jul 2026  
Inspection Time: 08:37 am

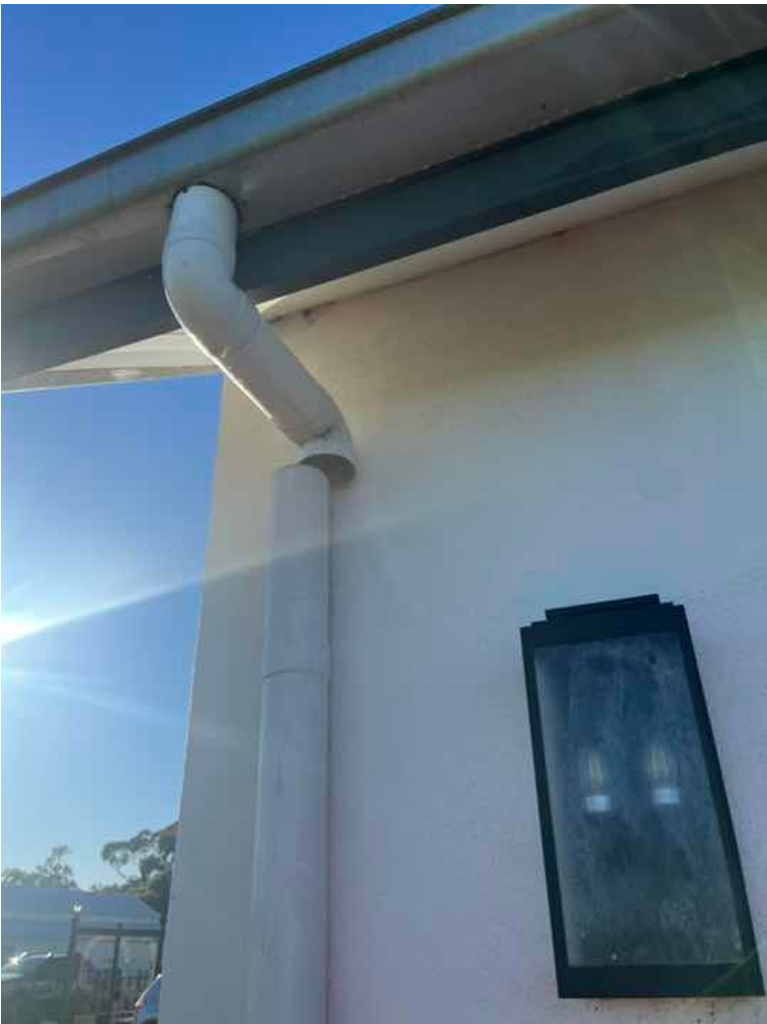
The down pipe join at the gutter is inadequately aligned to pipe at top. This has the potential to cause debris blockage. Recommendations: A qualified plumber should be engaged for repairs and recommendations.

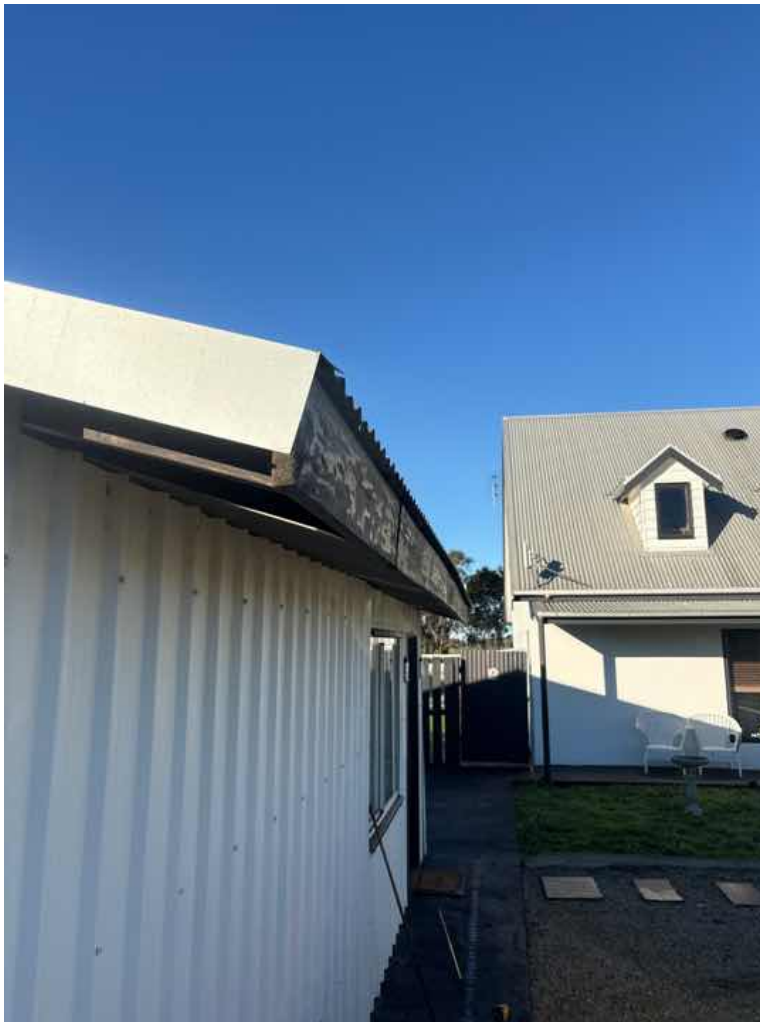
No guttering system installed. Contact a licensed roof plumber for advise on a suitable gutter system.

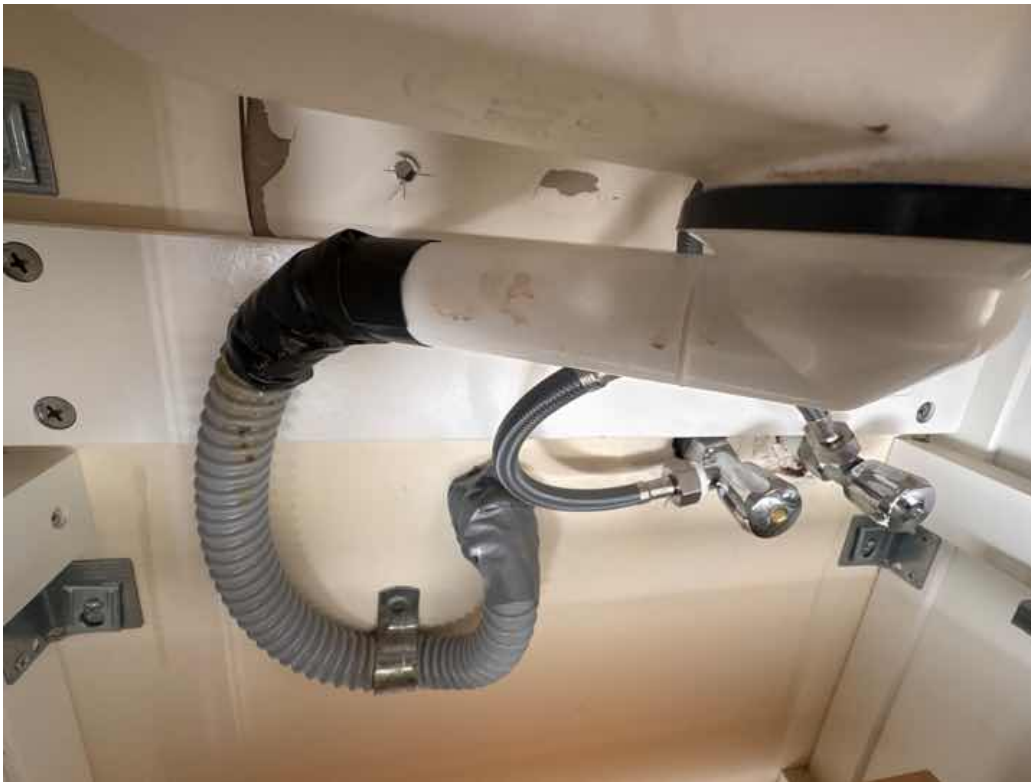
The trap under the sink isn't connected. A qualified plumber should be engaged for advice and recommendations.

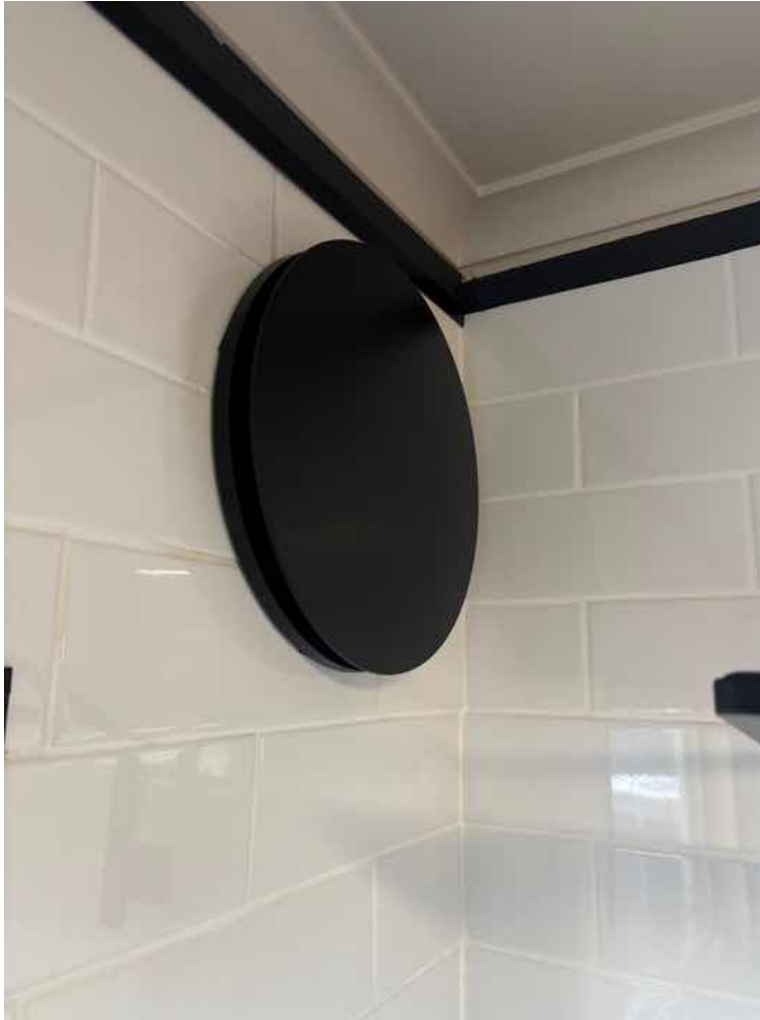
The exhaust fan is noisy - Have assessed by a qualified electrician.

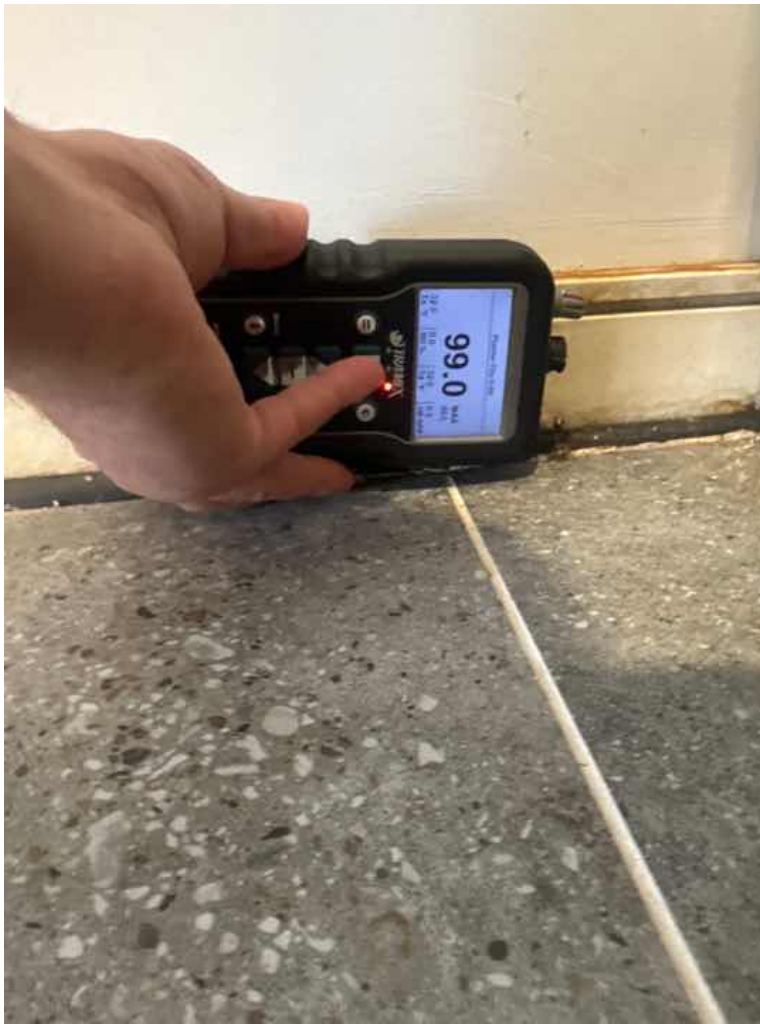
High moisture readings detected. There was no evidence of paint flake. Possible flashing issue from outside wall.

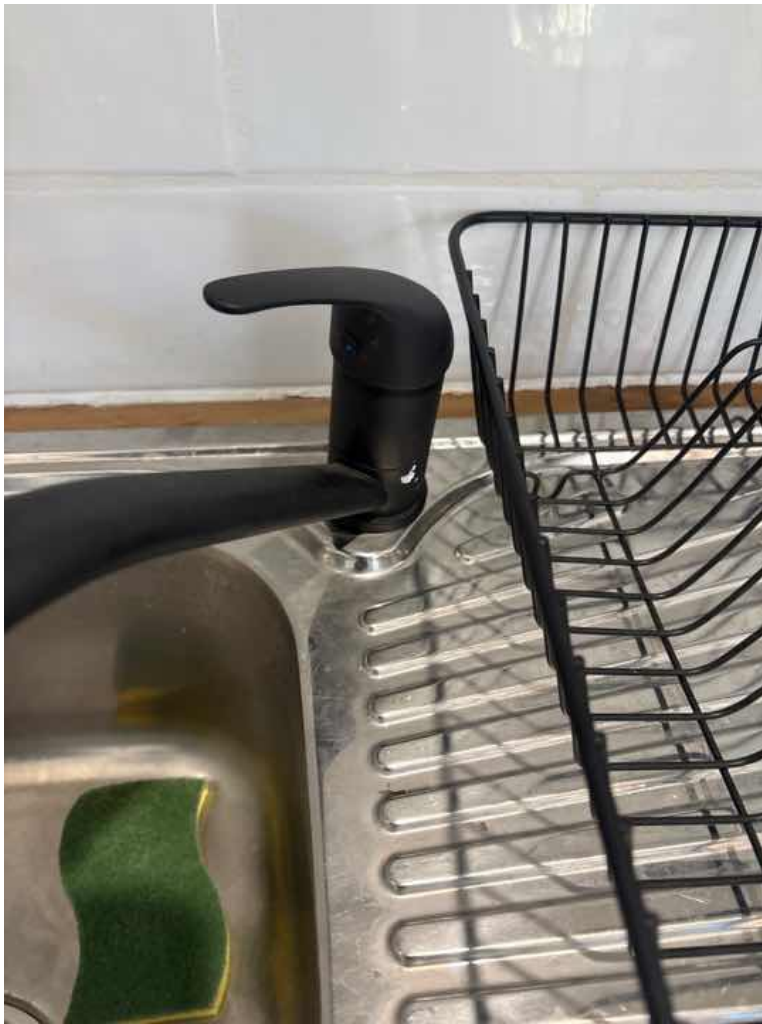
The tap / tap head is loose . A qualified plumber should be engaged for repairs.
